# Ankenævnet *for* Forsikring

Den 8. januar 2025 blev i sag nr. 101664:

Domus Forsikring A/S  
Stationsparken 26, 1.th.  
2600 Glostrup

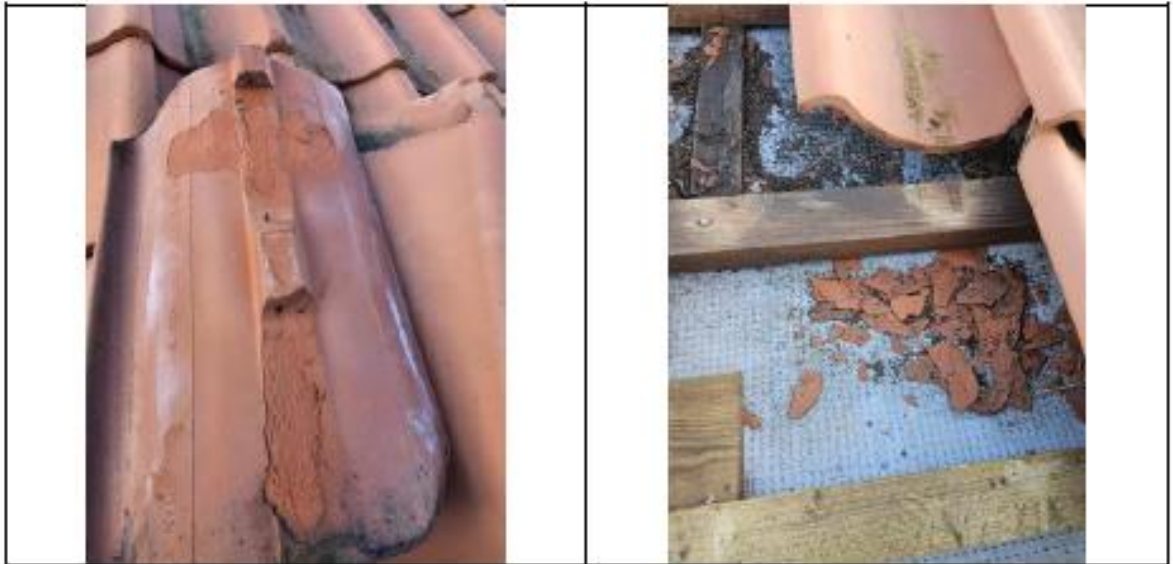
penters, I found out that the leakages were due to extensive rot in the tiles across the entire roof. Please find below the pictures taken of the rotted tiles by [sagkyndig].

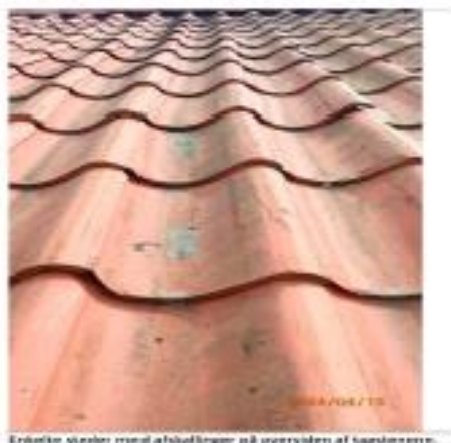
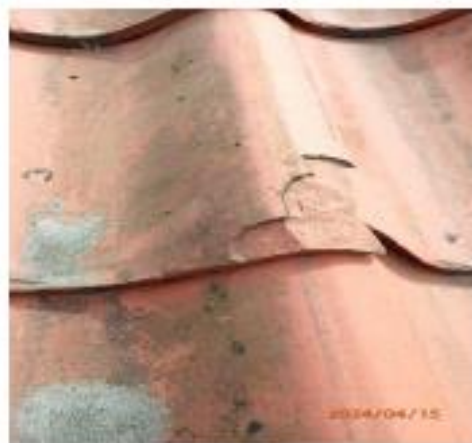
Moreover, regarding the first problem that concerns slightly open joints between the roof tiles, as Domus' surveyor has reported, there are peelings even on the upper side of the roof tiles. I do not assume you can blame these 'slightly open joints' as the cause of peelings noticed on the upper side of the roof tiles. How can Domus claim that the report had made rot and the possibility of leakage clear to me as the buyer based on this comment?

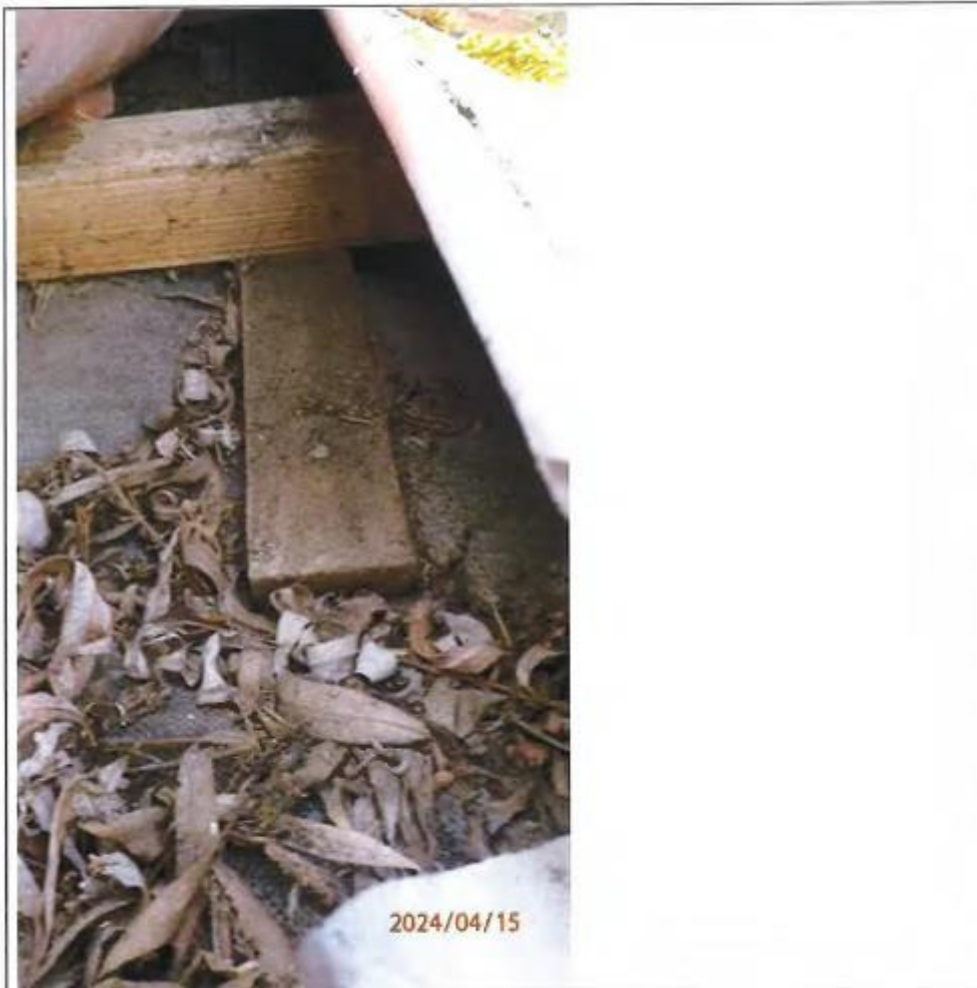
Undertag ved tagfod

Tagsten med åbninger i overlæg og tagsten monteret under den anbefalede taghældning har bevirket at der har kunne trænge vand ind som over tid har nedbrudt undertaget ved tagfoden. Afskallinger på tagstenene er aldersbetinget."

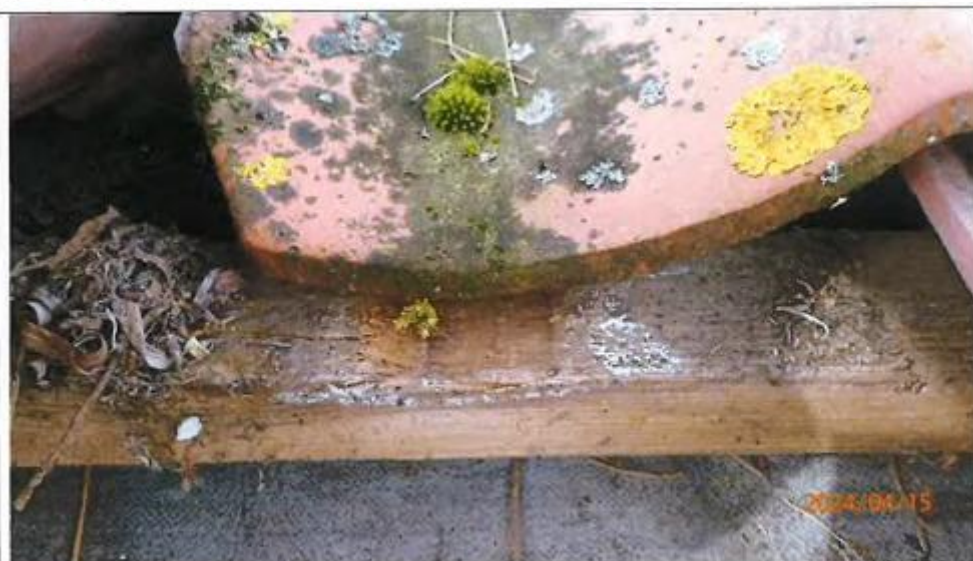
Der ses begyndelse nedbrydning i taglægter

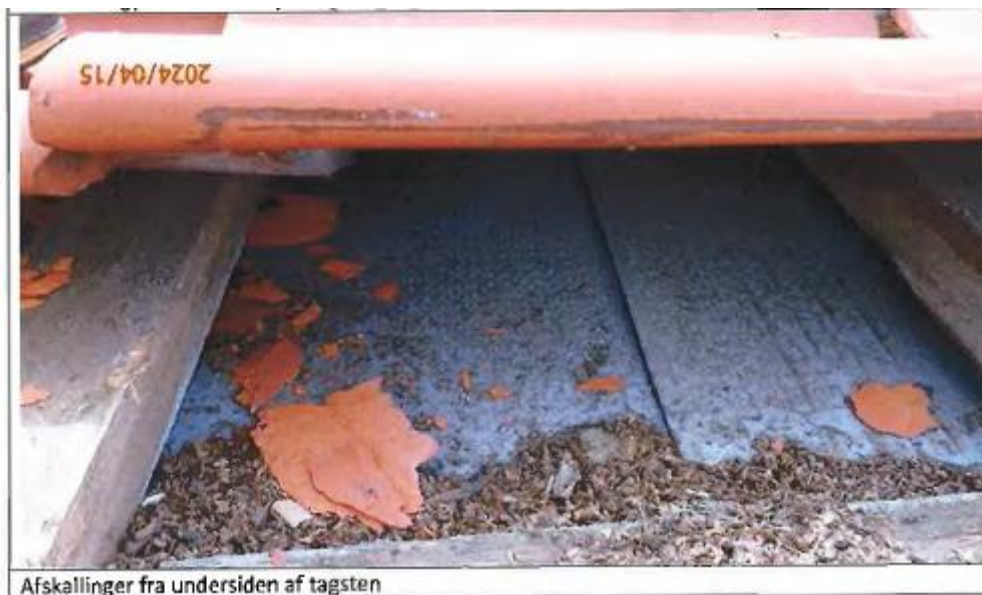
Afskallinger fra undersiden af tagsten

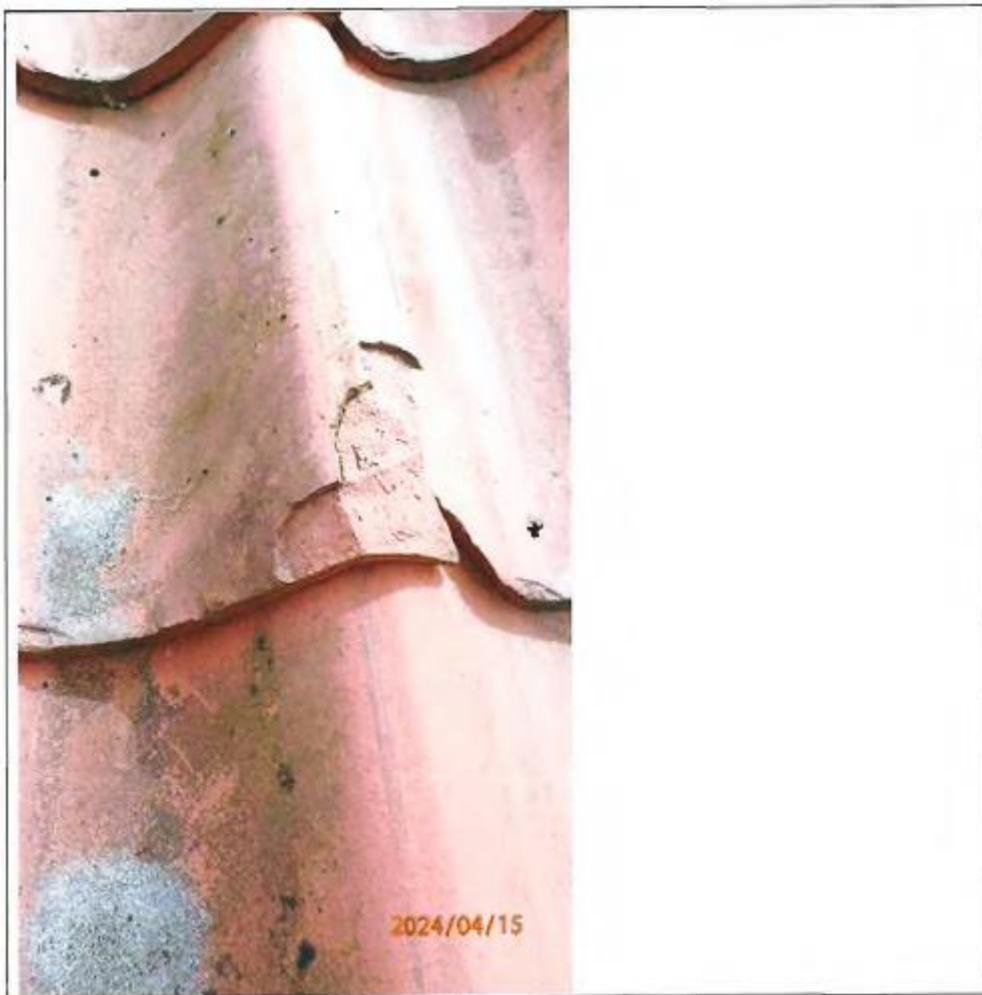
Undertaget på den ældste del af taget er udskiftet – muligvis iforb. med opførelsen af tilbygning
